TO: Mike Martindale  
DATE: October 4, 2018  
SUBJECT: Roof repairs at A&M Consolidated High School

# ROOF REPAIR PROPOSAL

**A&M Consolidated High School**  
**1801 Harvey Mitchell Parkway S. College Station, Texas 77840**

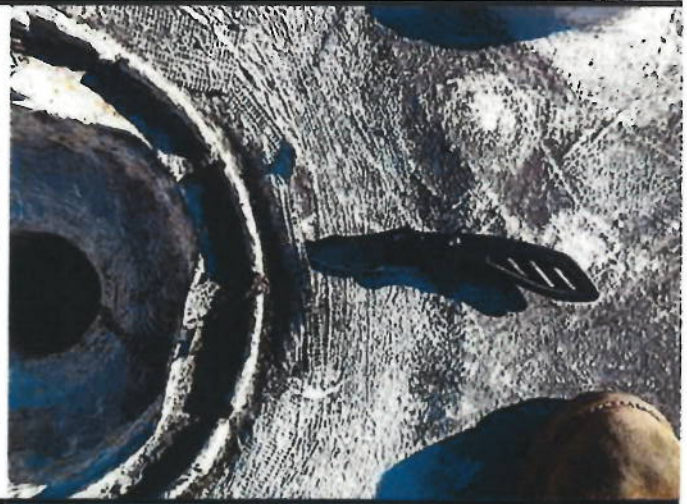
Photo 01

Leaking drain.

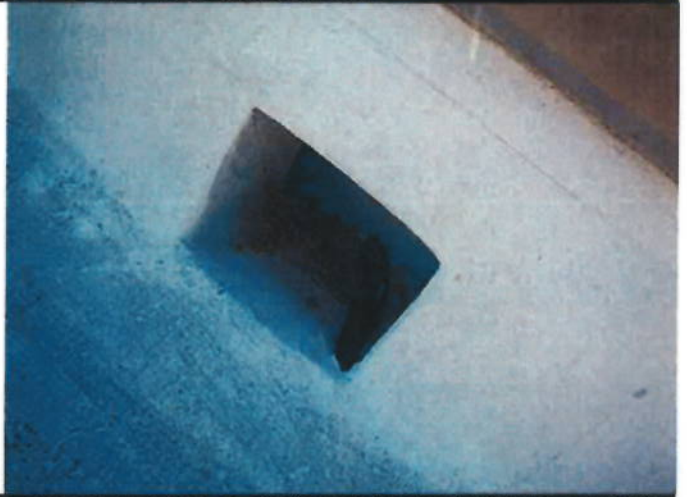
Photo 02

Open joint at scupper next to drain.

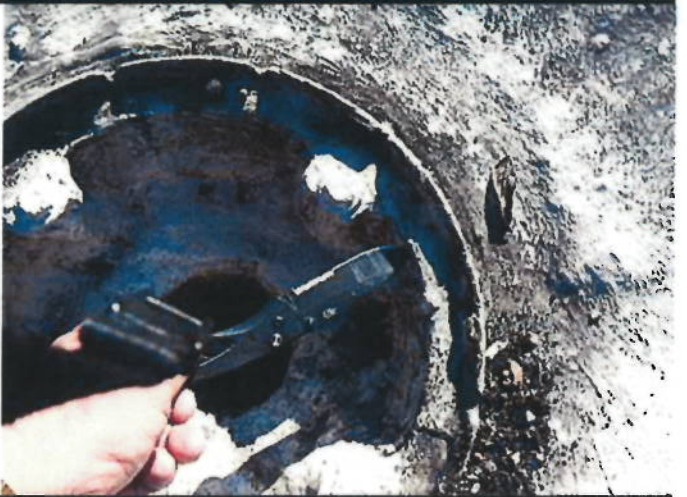
Photo 03

Gap in drain ring.

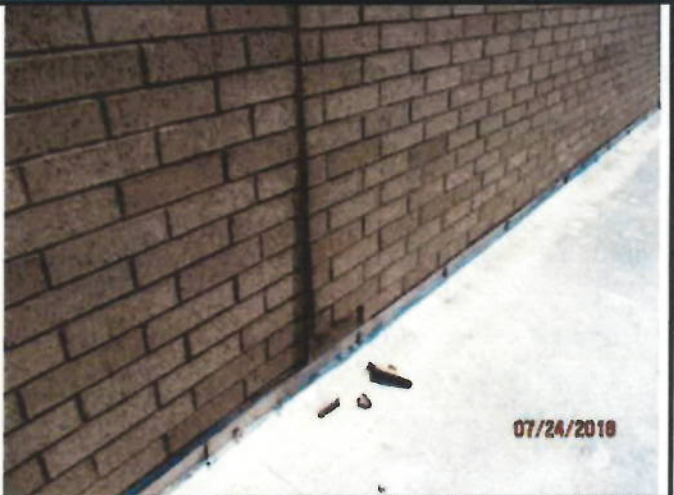
Photo 09

The brick wall is moving and is in danger of possibly collapsing.

The attached proposal from L.D. Tebben Company is to provide labor and materials to make numerous roofing repairs including removing part of an exterior brick wall that is failing. This portion of brick wall will be replaced with R-panel and metal studs.

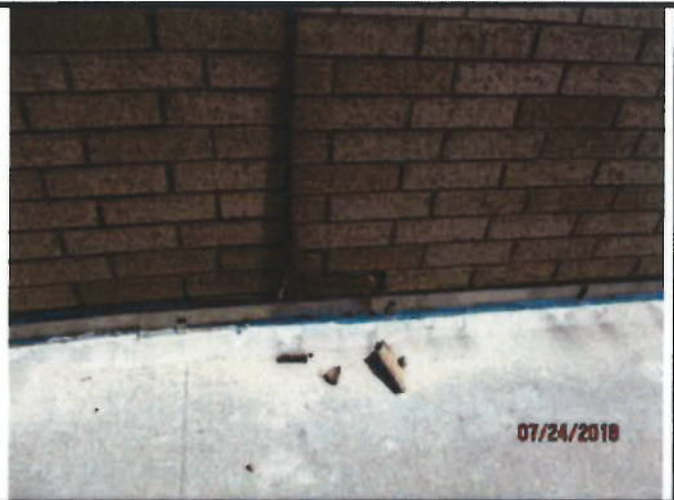
Photo 10

Note how the wall is moving away from the brick ledge and is collapsing bit by bit.

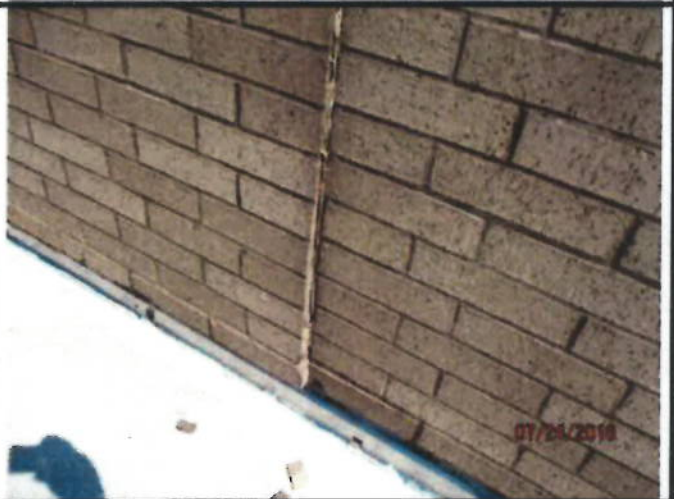
Photo 11

The control joints are breaking away from each other.

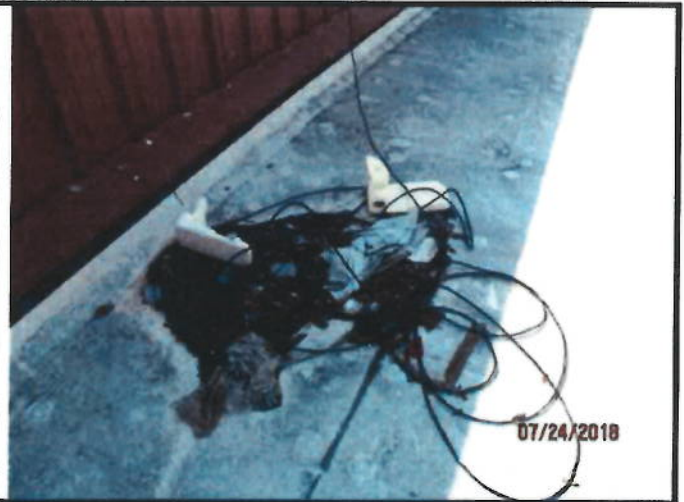
Photo 13

More debris on roof.
